# ChillCo, Inc.

Casino Resort in Mississippi, U.S.A.

Three 650 ton centrifugal chillers were stored in a 45' shipping container for 5 years. Gulf saltwater (remnants of hurricane Georges) caused moderate to severe metal degradation. All electrical components and control wiring were corroded beyond repair.

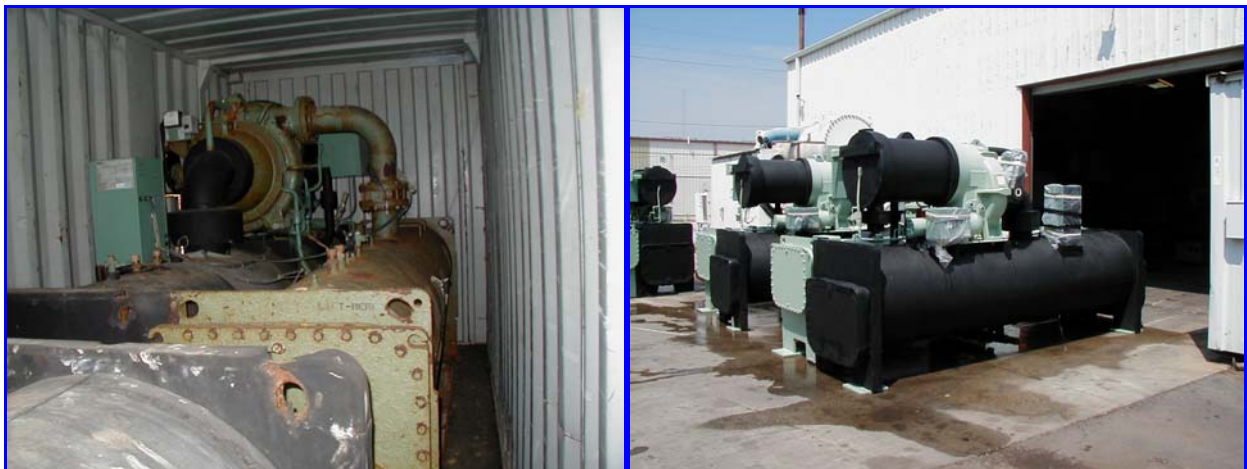
1. Three units jammed into a 45' shipping container.
2. Machines ready for delivery.

Units were disassembled, all operating components either refurbished or replaced as necessary to return to design specifications, controls were upgraded, vessels were sandblasted, painted and reinsulated, then units were test-run, logged and prepared for shipment.

6 weeks upon receipt of the machines, they were ready to ship back to the owner. Total expenditure was less than the cost of one new machine.
